Overrunning belt pulleys

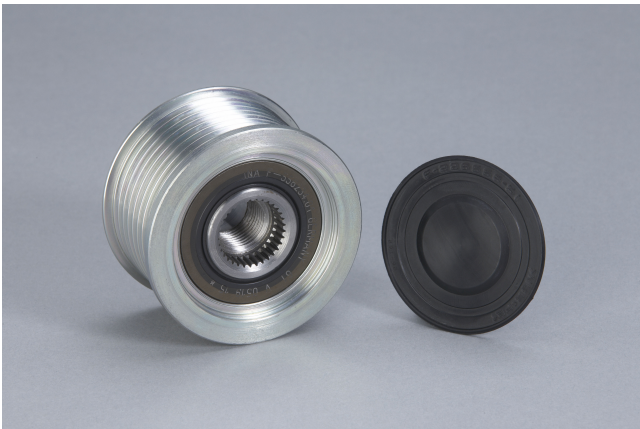
Function unlike electric motors, combustion engines exhibit non-uniform rotation. The four-stroke principle dictates that the crankshaft is continuously accelerated and decelerated. These oscillations are transmitted to the accessory drive, having a negative effect on noise characteristics and the service life of the drive belt. It is for this reason that the alternators in modern vehicles are fitted with an overrunning belt pulley (also known as an alternator freewheel). The overrunning belt pulley is mounted on the alternator's drive shaft. It transmits the drive force in one direction only. In so doing, it decouples the alternator from the oscillations of the crankshaft. Thanks to this technical trick, the belt drive runs more smoothly and more quietly, and the service life of the drive belt is extended.

Protection of the environment the solid steel overrunning belt pulley has a V-ribbed belt profile. The overrunning unit inside the belt pulley is fitted with a bearing filled with sufficient grease to ensure lubrication for life. Overrunning belt pulleys are made primarily from metal and can easily be recycled
