Drive shaft

Function

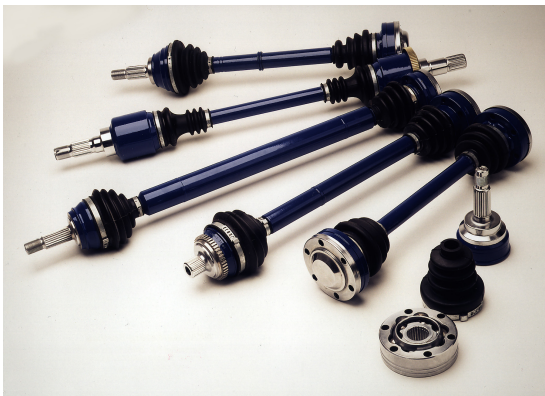
Drive shafts for cars with front wheel drive consist of the outboard fixed joint, the inboard constant velocity joint and the connecting shaft. They also include elements such as the anti-lock system ring and the torsion damper. The basic design of the outboard fixed ball joint, the constant velocity joint, dates from the 1930s.

In most cases the inboard CVJ takes the form of a slip joint to allow the drive shaft to follow the movements of the wheel suspension. At the front axle (leading axle) the outboard joint must transfer the torque effectively through a large angle (up to 52 degrees). At the rear axle the angles of the outboard joints are considerably smaller.
